## Round Lake Beaches

The following is a brief history of how a beach was formed on Round Lake by a former Round Lake owner now deceased on the south shore of Big Round Lake. This is not recommended now and I believe is not legal without DNR permits.

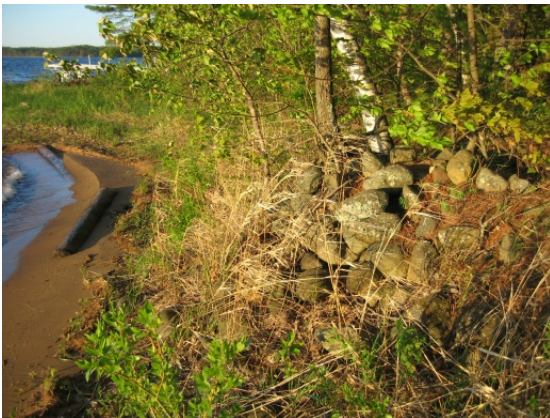
Residua of fieldstone dam that once went 15 to 20 feet into water. The top left of picture shows few thousand square foot beach now present with mature cover.

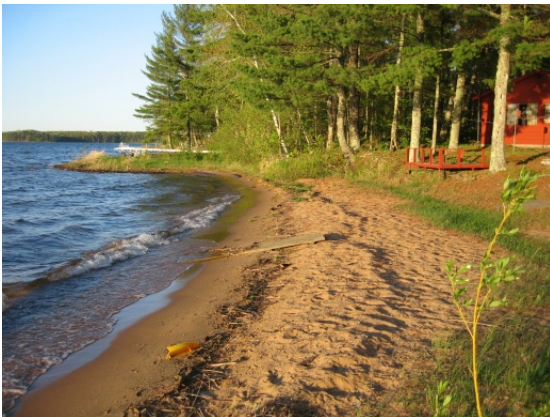
This beach was made with fieldstone berm or dam and the water once went up to the old red deck by the shoreline. At the top

**upper left shows the other beach formed by a berm just beyond where the red deck is. The beach in the foreground was formed by a berm where picture was taken.**

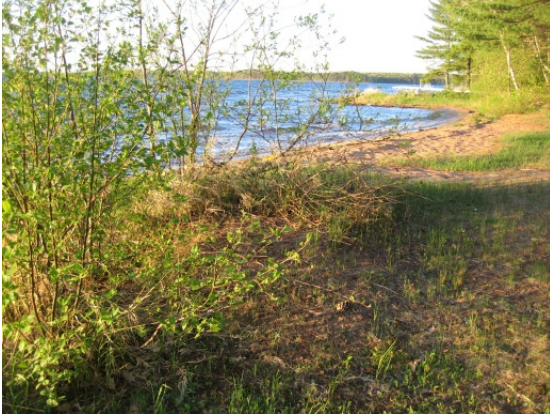
**The shrubs are growing where a fieldstone berm is. The berm is covered with vegetation and there is a mound there now. The fieldstone that once protruded into the lake is covered with sand and now sunken. All of the visible beach in this picture was formed by this fieldstone berm.**

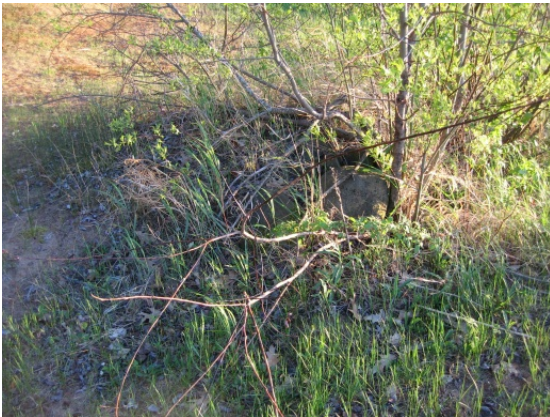
**Residua of fieldstone berm on shore.**

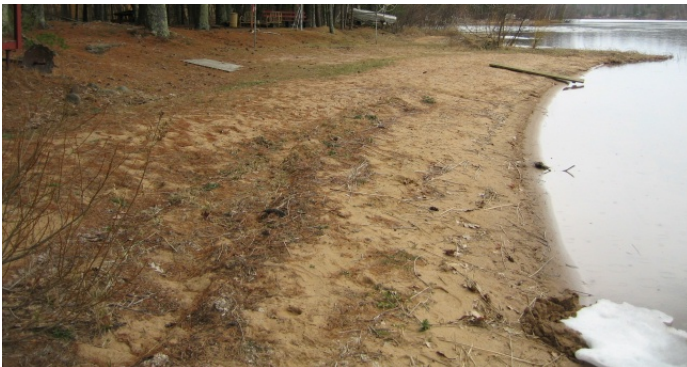
**Entire Beach was made by fieldstone berm which was located at the point in the top right of picture. The water used to go almost to tree line.**
